News Release

20 February, 2014
Nuclear Regulation Authority, Japan

On 20 February 2014, TEPCO reported the Nuclear Regulation Authority (NRA) on the incident of water leakage at Fukushima Daiichi Nuclear Power Station pursuant to the Act on Regulation of Nuclear Source Material, Nuclear Fuel Material and Reactors (Article 62-3, http://www.nsr.go.jp/english/library/data/related_act_1218.pdf) as follows:

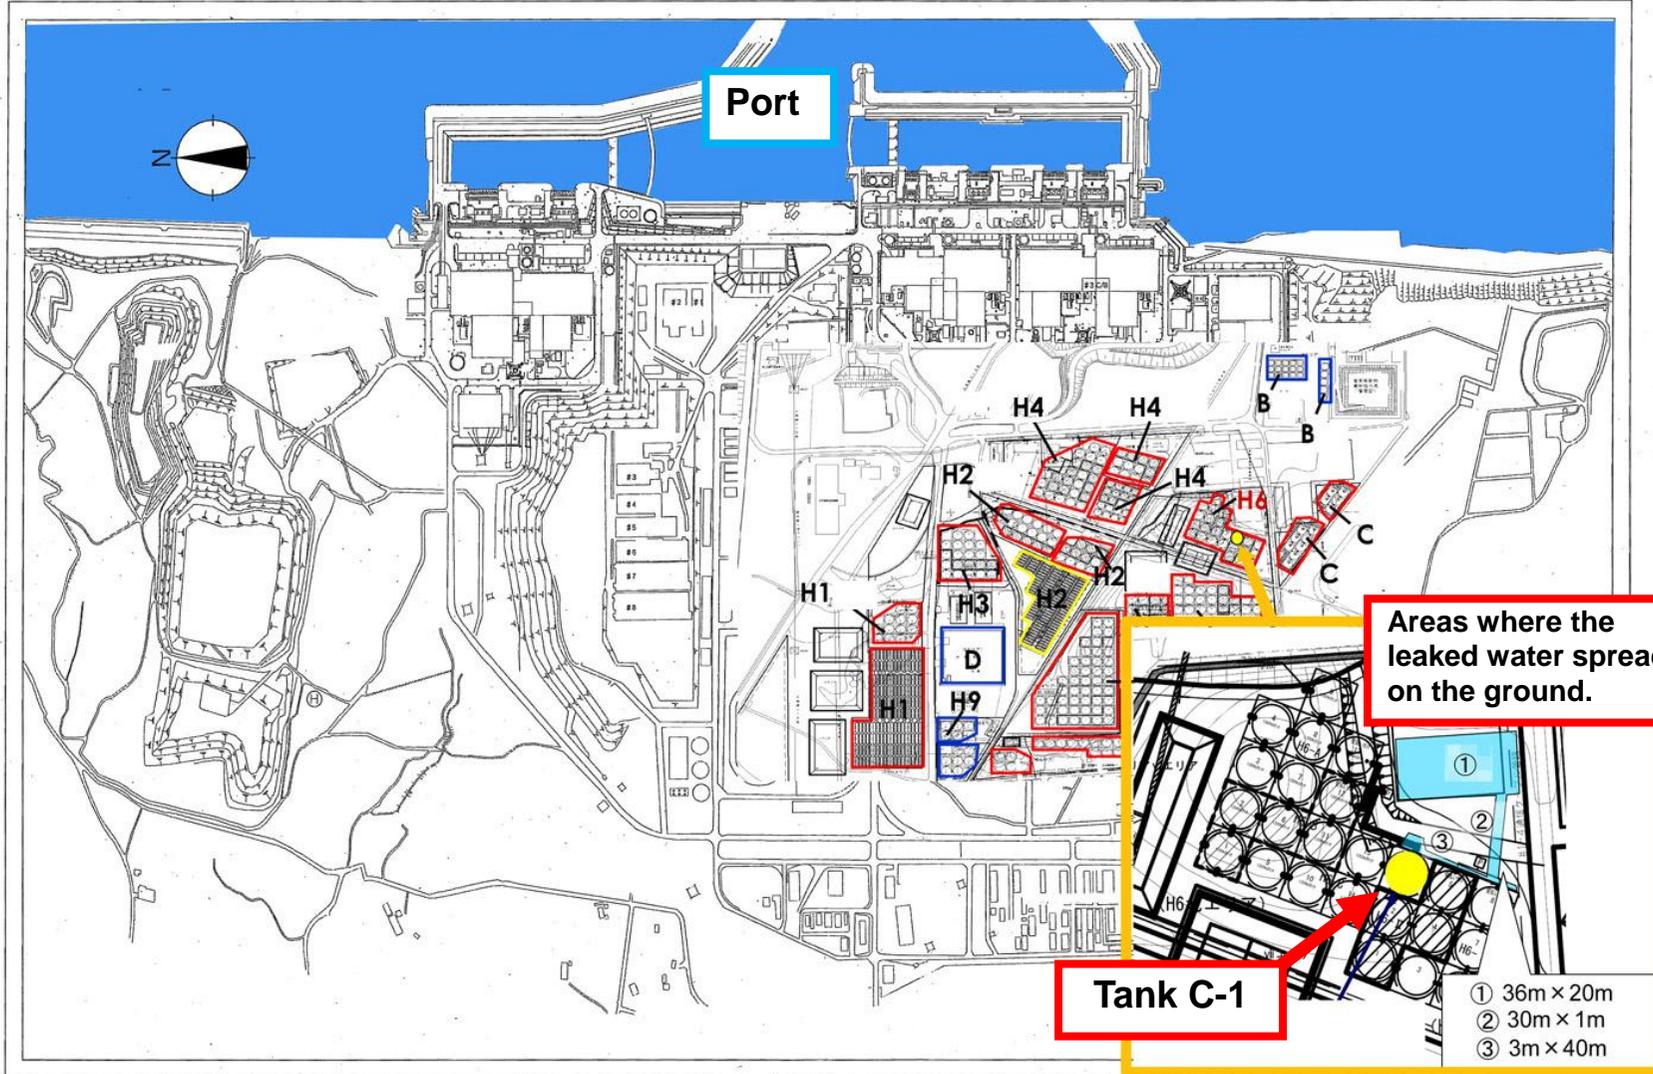
The place of water leakage on site of Fukushima Daiichi Nuclear Power Station

- At 23:25 (Japan time) on 19 February, TEPCO found that water was leaking from the upper part of Tank C-1 in H-6 Tank Area, which has stored the water that was condensed by RO (reverse osmosis desalination facility) after the treatment by SARRY (cesium removal facility), to the dike surrounding H-6 Tank Area and to the outside of the dike through the rainwater drainpipe running from the upper part of Tank C-1 to the ground surface beyond the dike.

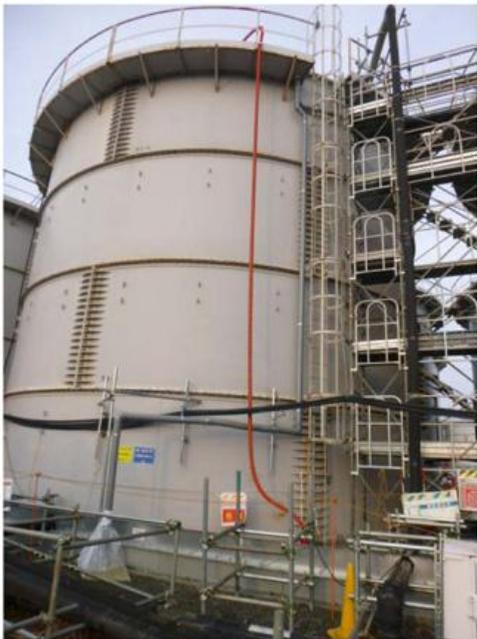
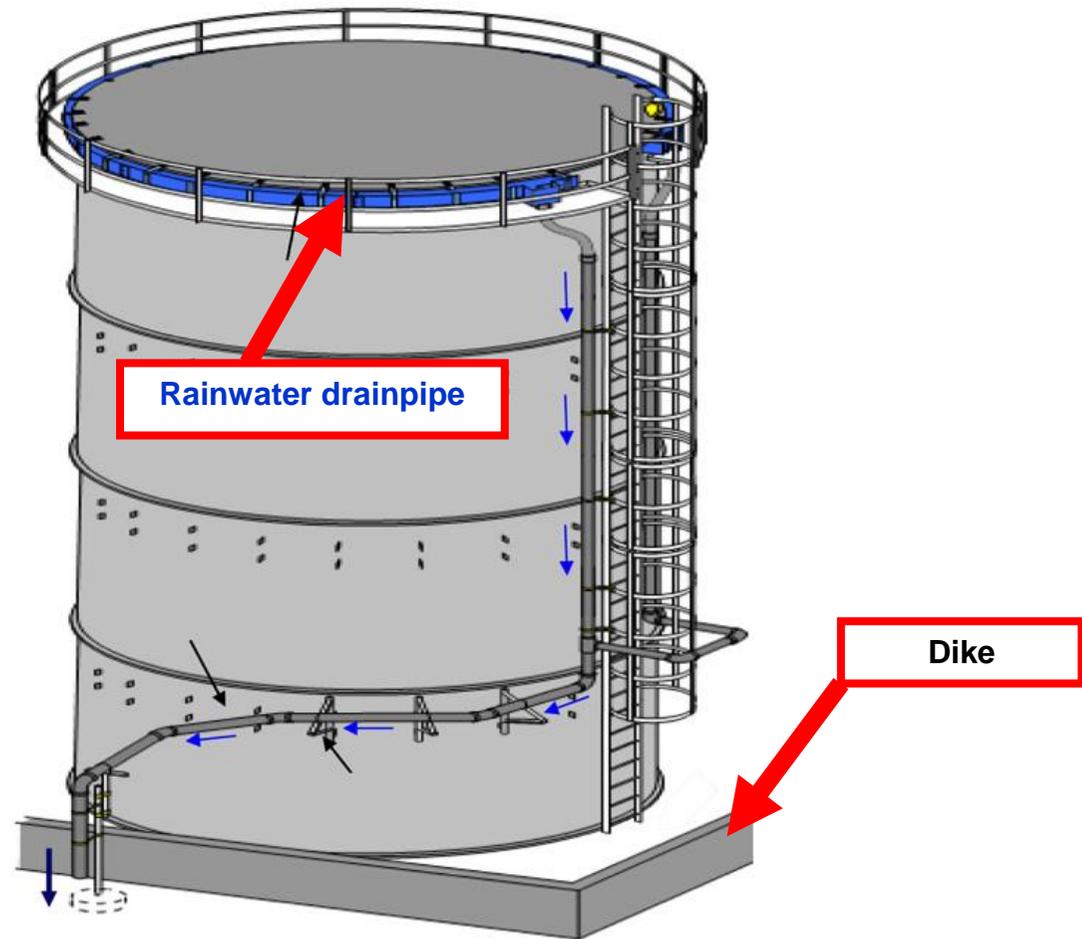
- At 05:40 (Japan time) on 20 February, TEPCO succeeded in stopping the water leakage by means of closing the valves installed between Tank C-1 and RO and transferring some amount of the water stored fully in Tank C-1 to other tanks in H-6 Tank Area. The amount of water, which leaked to the outside of dike, was estimated by TEPCO to be approximately 100 m³.

- To take measures to stop the water leakage promptly;
- To figure out the scope of areas contaminated by the leaked water;
- To figure out the total amount of leaked water and the concentration of radioactive materials in the water;
- To remove the contaminated soil to a storage place on site; and
- To check whether water leakage from the same-type tanks as Tank C-1 is happening or not.
