Evaluation of the report of Tokyo Electric Power Company regarding the leakage from the RO concentrated water storage tank at the Fukushima Daiichi Nuclear Power Station

31 March 2015
Nuclear Regulation Authority, Japan

10 December 2014
Nuclear Regulation Authority, Japan

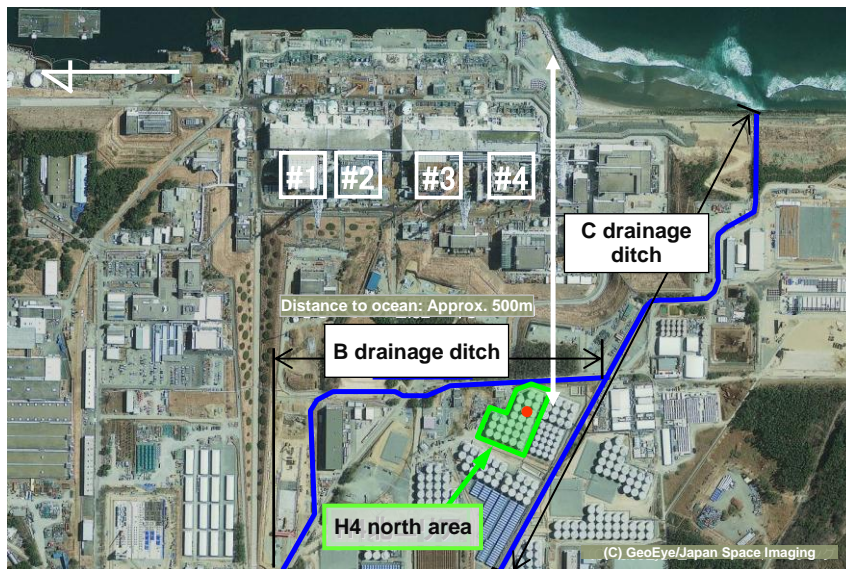
Figure 1 H4 north area^{*2}

Around 9:50, 19 August 2013, a worker patrolling the site of the contaminated water storage facility found that there was an accumulation of water inside and outside of the dike built to surround the RO concentrated water tanks in the H4 north area (refer to Figure 1), and that the water inside of the dike was running outside of the dike from the drain valve of the dike. At the time, the portable dosimeter set off an alarm.

Immediate measures were taken to prevent the spread of the leakage, and to collect the leaked water, which led to the reduction of the water level of No.5 tank of the RO concentrated water tank in H4 north area (hereinafter, referred to as "leaking tank").

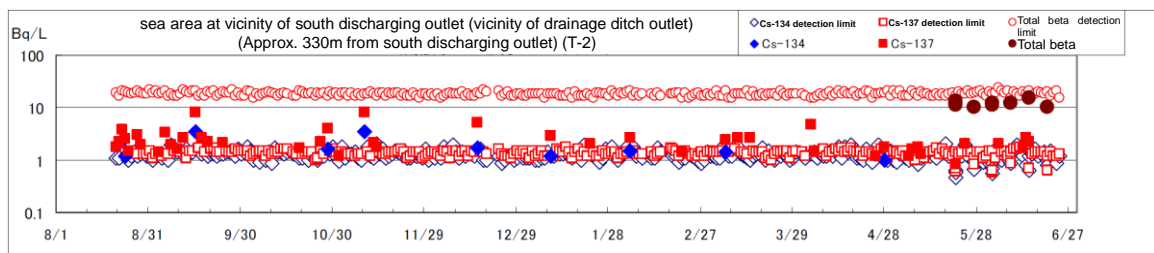
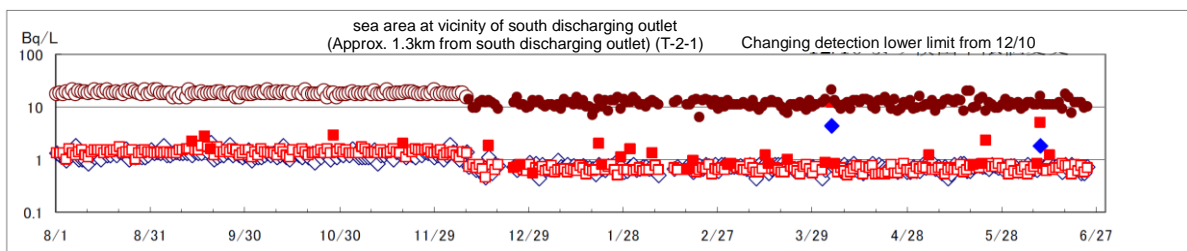
Figure 3 Results of seawater monitoring²

In terms of an environmental impact, no obvious increase in measurement results of total beta was detected in the seawater monitoring (refer to Figure 2) at the north/south discharging outlets (refer to Figure 3).

There is no obvious fluctuation in the monitoring results at the vicinity of the south discharging outlet (T-2-1) before and after the leakage of the tank. There is no detection of total beta that suggests leakage of the contaminated water leaked from the tank (total beta/radioactive cesium concentration rate is 10^3 to 10^4 (refer to Table 3)) to the ocean at the point T-2 which is the closest to the C drainage ditch after finding leakage.

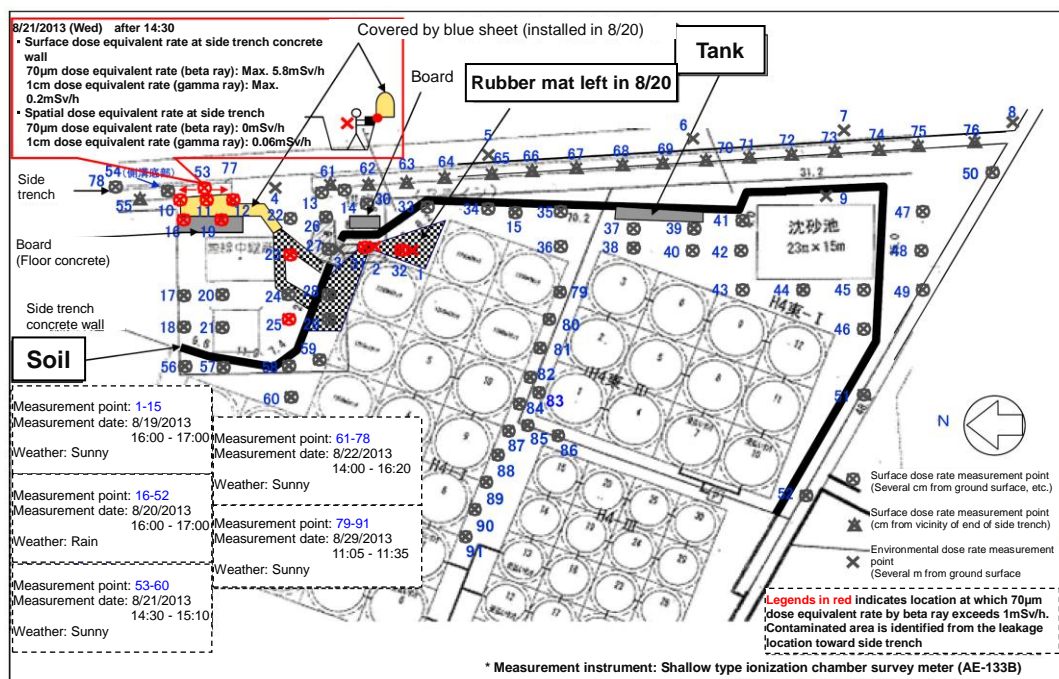
Figure 4 Radiation dose rate survey on ground surface (measurement point)^{*2}
(Table 1 shows inspection results of radiation dose rate)

Figure 4 and Table 1 show the results of radiation dose rate survey of the contaminated ground surface. Figure 5 shows recovery locations.

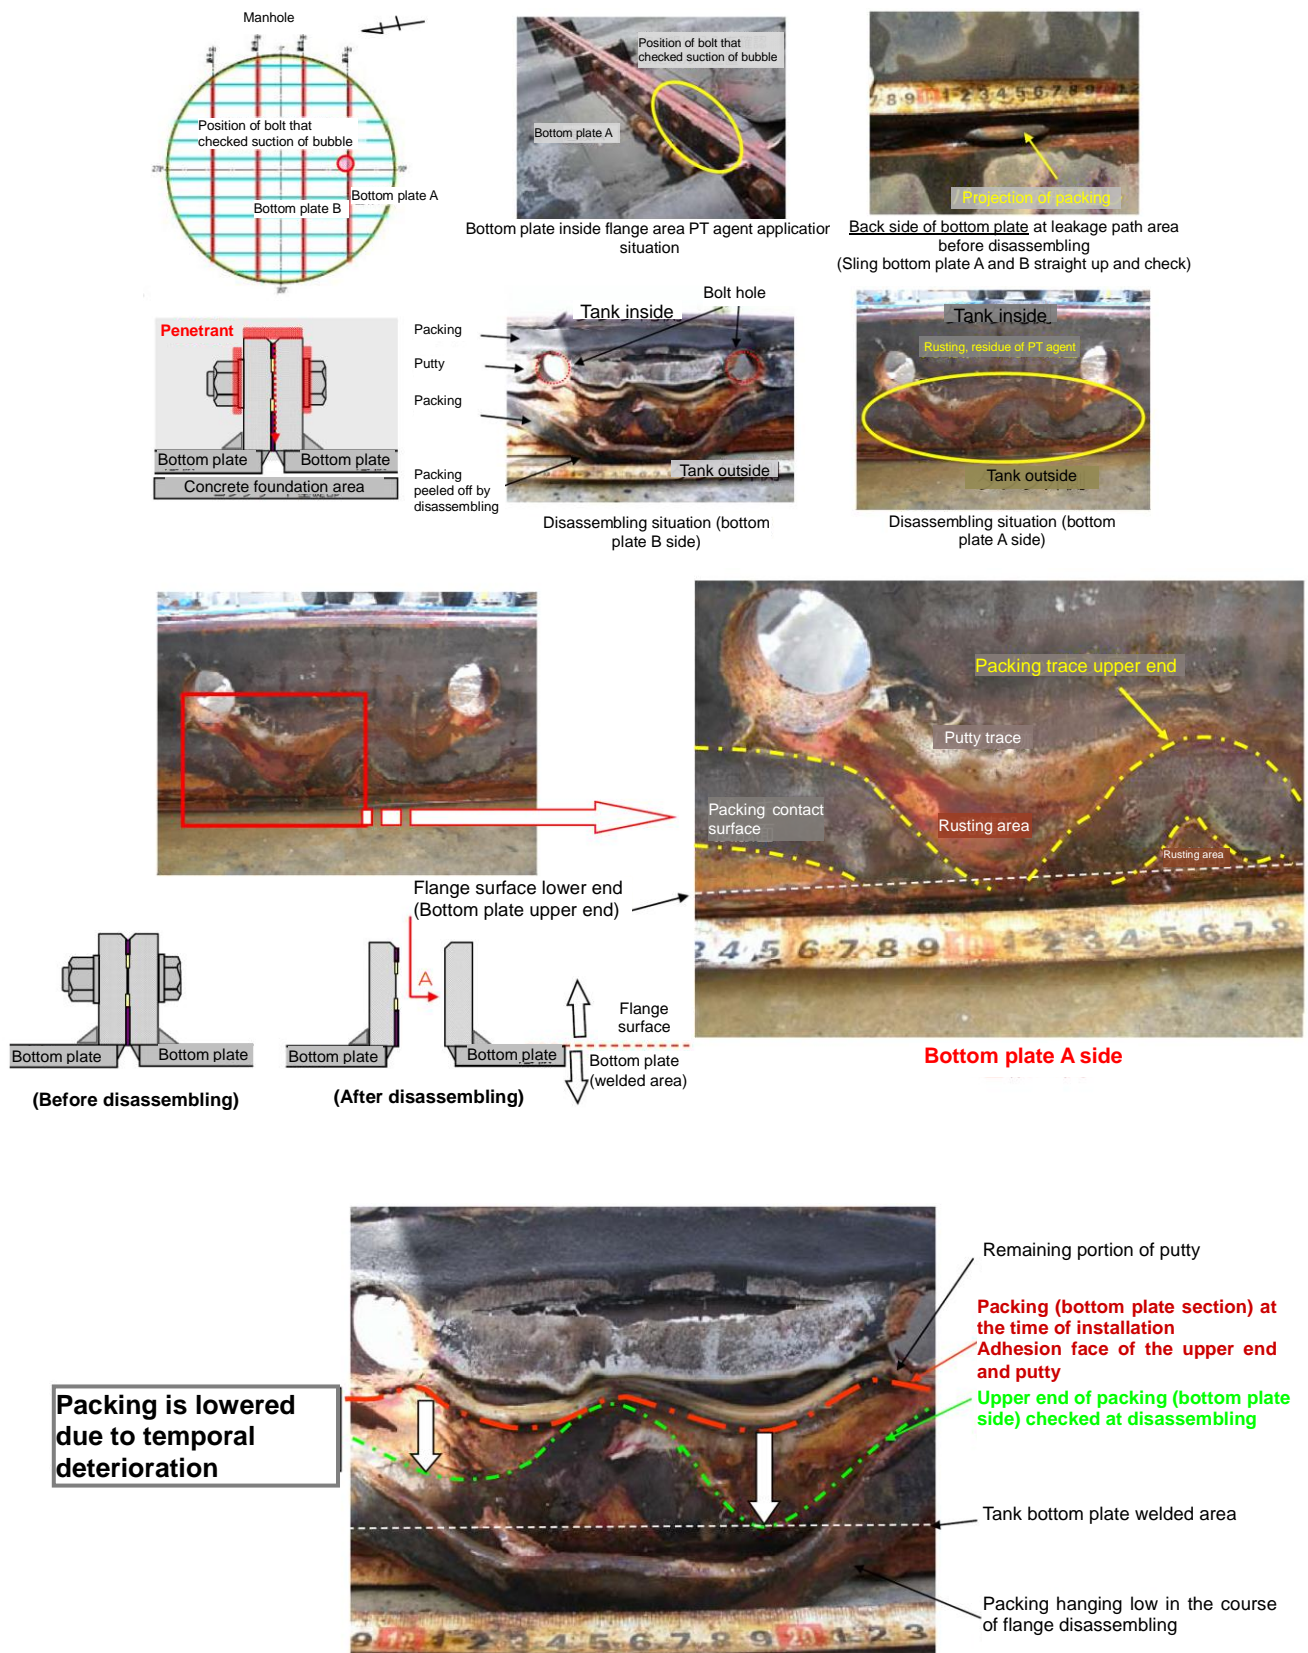
Figure 7 Location of leakage^{*2}

As a result, it was found that the leakage point was located at the discovered protrusion

of packing at the flange section of the tank bottom plate (refer to Figure 7). The assumed cause was estimated to be a reduction of bolt torque to tighten the packing, due to the impact of thermal expansion/shrinking of the flange caused by a subtle waving of the packing at the time of tightening the bolt at the location of the leakage. In addition, it was accompanied with the opening of the lower end of the flange. It is presumed that this led to the protrusion of the packing which shifted downward out of the bottom of the tank due to the inability to resist the water pressure of the tank.

Flange type tanks on which the leakage was discovered shall be replaced with welded tanks, and the replacement shall be preferentially applied to the TYPE-1^{*1} on which the leakage was found.

As tentative countermeasures until replacing with welded tanks, the implementation of following measures shall be considered (refer to Figure 8): 1) Waterproofing by caulking, etc. at the bottom of the tank, 2) Filling sealing material underneath the bottom plate, and 3) Filling sealing material at the bottom plate section (inside).
