Evaluation of the report of Tokyo Electric Power Company regarding the leakage from the 4000-t square steel tank cluster at the Fukushima Daiichi Nuclear Power Station

28 April 2015

Nuclear Regulation Authority, Japan

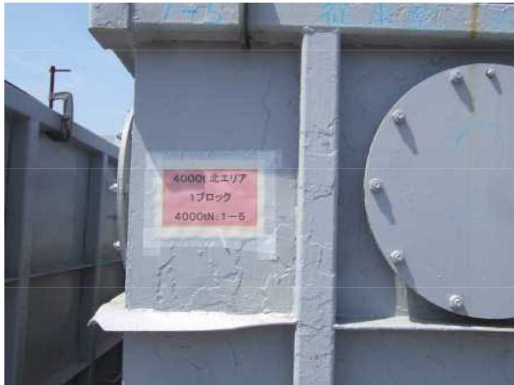
Photograph 1 Leaking notch tank

In the area concerned, water was observed to be dripping from portions around the bolts attached near the top panels of two tanks. The dripping rate was approximately one drop per second. We notified the electric utility of this event and ordered them to check the details.

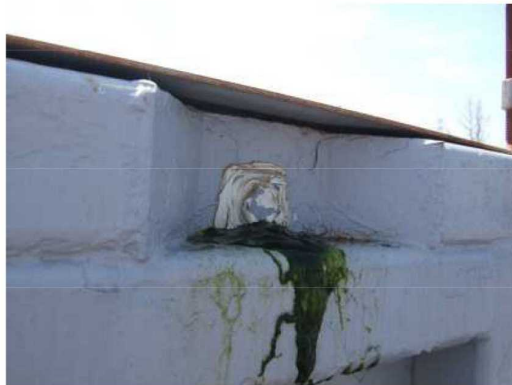
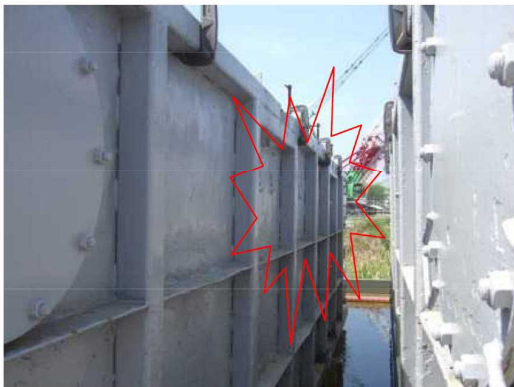
Photograph 2 Leaking portion

Photograph 3 Leaking portion

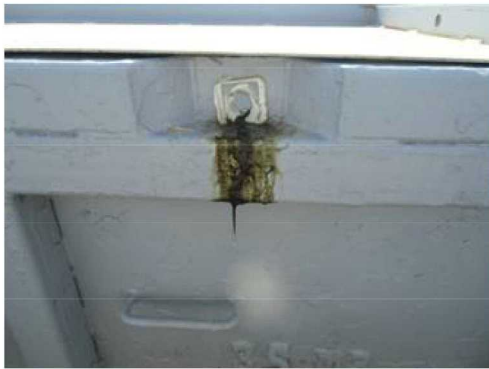
Rainwater entered the tanks through these openings that had formed at the tanks' top panels, gradually leading to an increase in the water level of the 1000 t notch tank cluster. As a result, stored water leaked into the dike from the portions around the bolts, which had low cut-off performance.

Leakage from tank No. 1-3

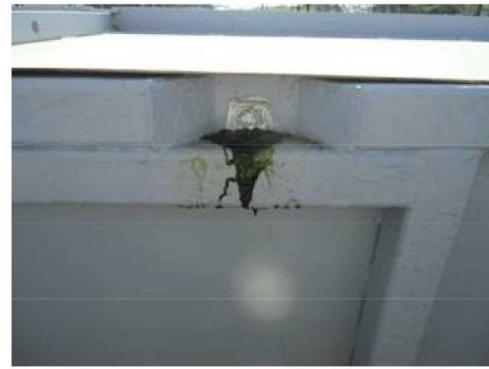
Leakage from tank No. 1-5

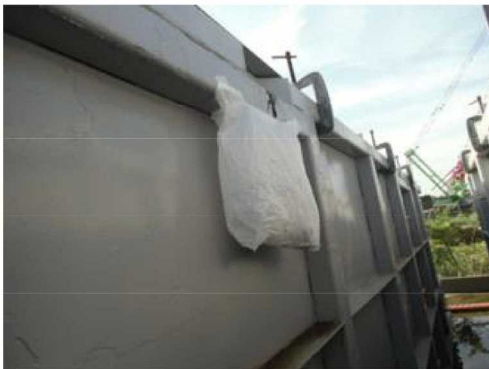
Vinyl bag attached to hold leaking water

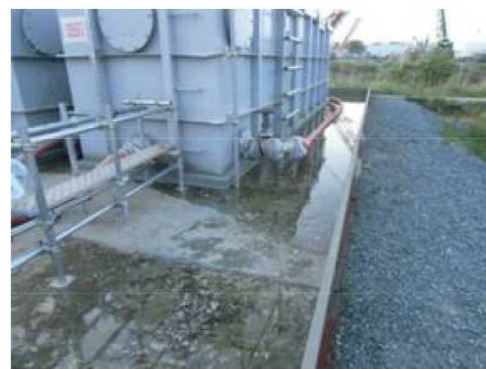
Rainwater accumulated in the dike

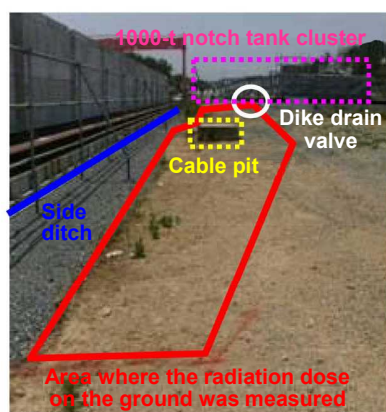
Despite the fact that the leaking water was dripping into a dike, the dike’s drain valve remained open. Tokyo Electric Power Company (hereinafter, referred to as “TEPCO”) measured the radiation dose (70 µm dose equivalent rate (β rays)) on the ground around the drain valve and outside the dike, finding a maximum radiation dose of 0.028 mSv/h within the area up to a distance of approximately 40 m from the drain valve. TEPCO therefore concluded that water in the tanks leaked outside the dike (refer to Figure 4).

- a. The drain valve, which remained open, allowed stored water that leaked into the dike to further leak outside the dike.
- b. No patrol was performed around the notch tank cluster, and thus the leakage from the portions around the bolts was not discovered.

Leakage to outside the dike

Area outside the dike

- b. Countermeasure to ensure the dike drain valves are closed
 - All drain valves of dikes in the notch tank cluster shall remain "closed." Rules regarding this operation shall be stipulated in company manuals.

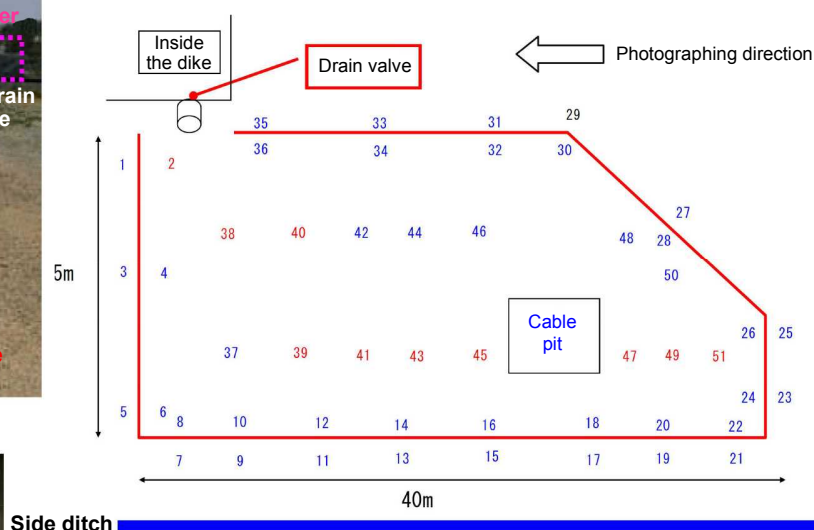
Figure 4 Data on leakage outside the dike (extracted from the TEPCO report)

Radiation dose measurement points on the ground
outside the dike

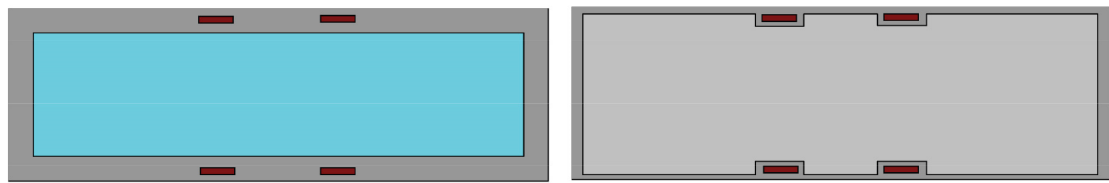
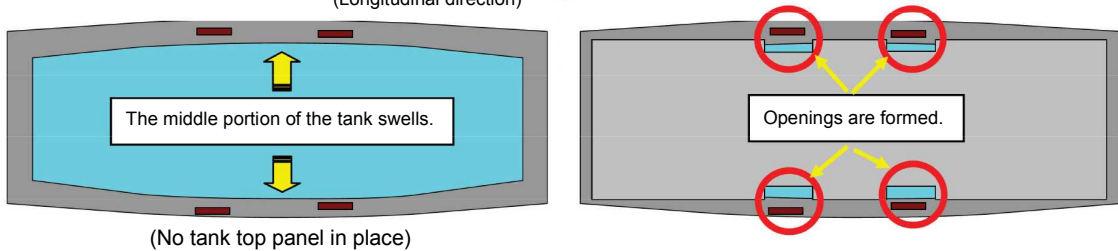
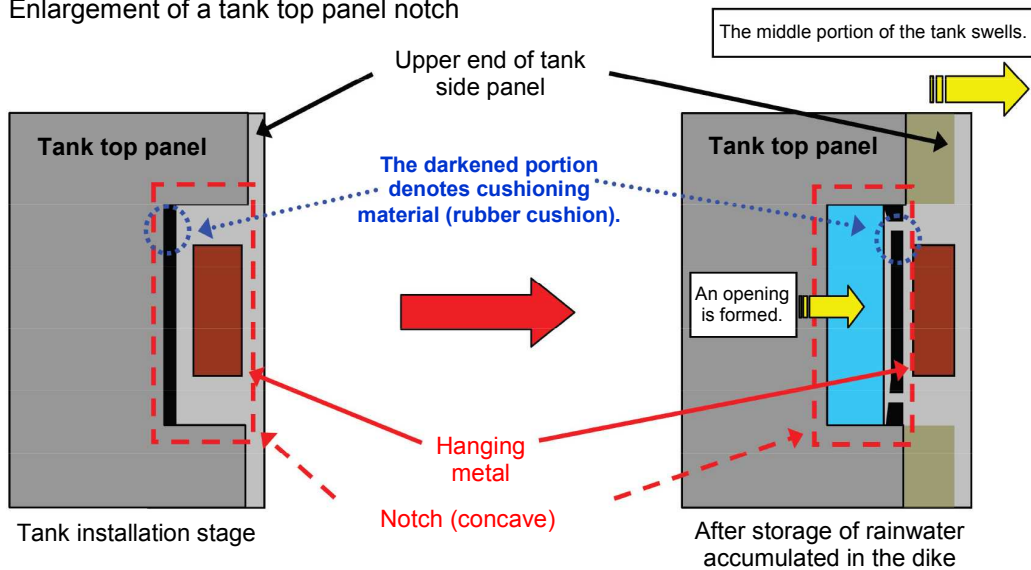
**Figure 5 Formation of an opening at a notch tank top panel
(extracted from the TEPCO report)**

While storing water, the tanks swelled in the middle of the upper-end part of their side panels. This swelling caused gaps (openings) to develop between the tanks' top panels and hanging metal attached to the upper end of the tanks' top panels (refer to Figure 5).

No gaps exist between the notches of the tank top panel and the hanging metal at the upper end of the tank side panels during the tank installation stage.

The middle portion of the tank swells.

Openings are formed.

The notch tank stores rainwater accumulated in the dike, and its middle portion thus swells outward. As a result, gaps (openings) are formed between the notches of the tank top panel and the hanging metal at the upper end of the tank side panels.

- Covers shall be installed over the notch tank cluster to prevent rainwater from entering the openings along tanks' top panels and to prevent rainwater accumulation from increasing in the dike for the notch tank cluster.

- Inspections shall be carried out on the notch tank cluster once a week to confirm that tanks' water levels do not exceed the reference upper limit (approximately 20 cm below the tanks' top panels).

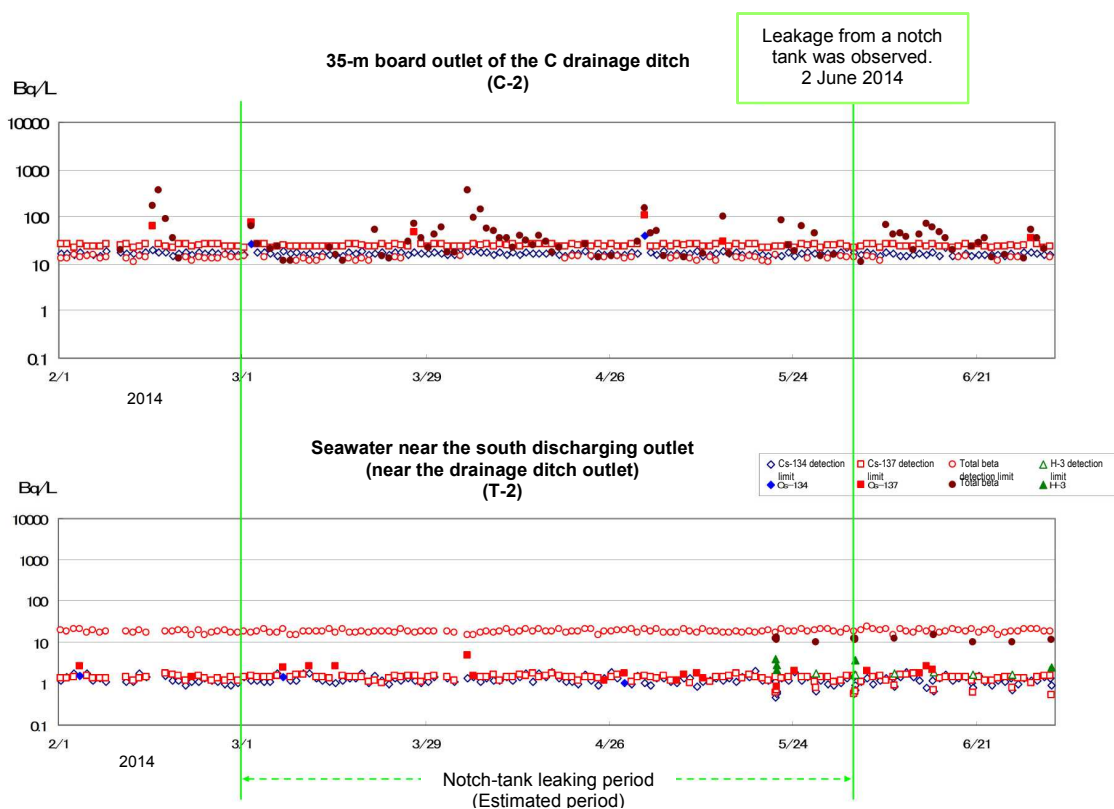
Figure 6 Results of drainage-ditch and ocean monitoring (extracted from the Secretariat of the NRA's document for a meeting with TEPCO)

There is no obvious fluctuation in the results of monitoring before and after the leakage occurred in the vicinity of the 35 m board outlet (C-2) of the C drainage ditch and the vicinity of the south discharging outlet (T-2). The NRA therefore concludes that this event did not cause ocean contamination that raises any concerns about effects on health or the environment (refer to Figure 6).
