Evaluation of the report of Tokyo Electric Power Company regarding the leakage from the RO-concentrated water storage tank (H6 area C1 tank) at the Fukushima Daiichi Nuclear Power Station

15 April 2015

Nuclear Regulation Authority, Japan

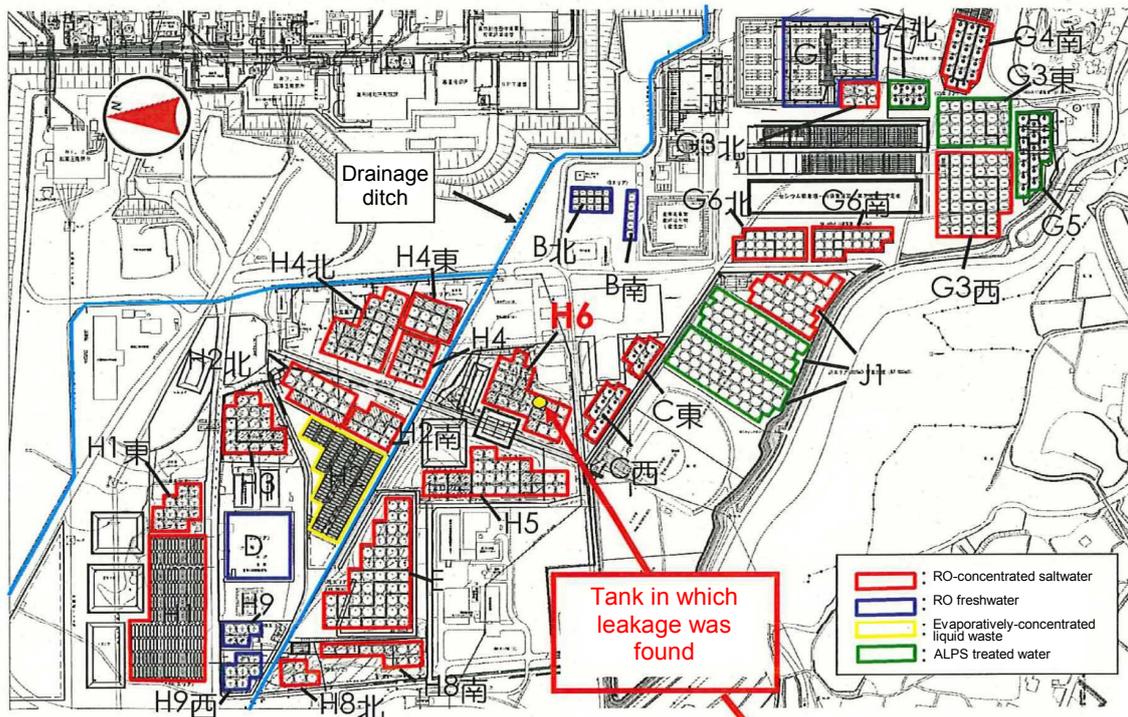
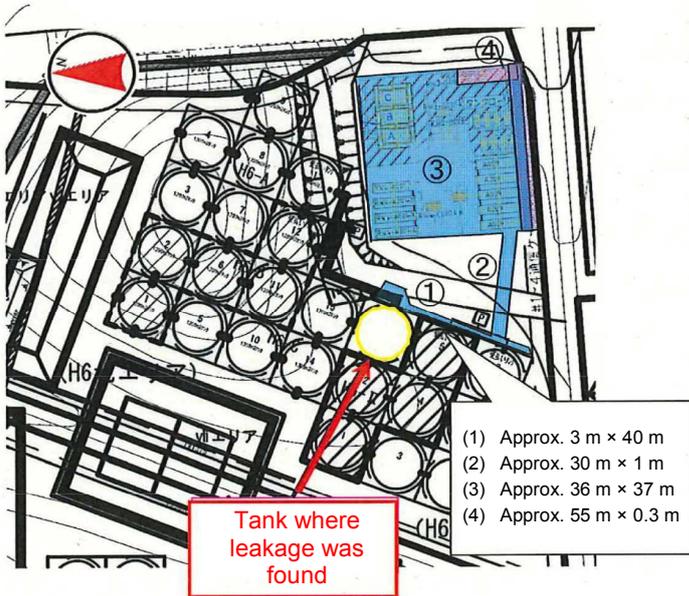
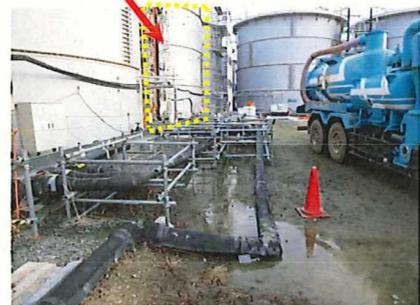
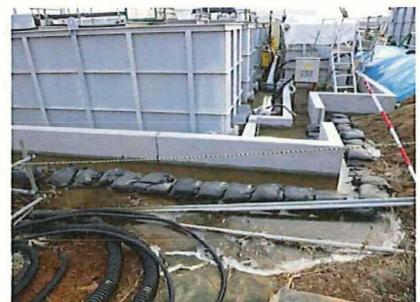
Figure 1 H6 tank and leakage location (extracted from the TEPCO report)

Around 23:25 on 19 February 2014, water was found to be dripping from the top ceiling plate of the RO-concentrated water¹ storage tank (C1 tank²) in the H6 tank area. When the water surface inside the tank was checked from the top of the C1 tank, it was found that the water level had reached the ceiling plate, and water was leaking from the top ceiling plate of the C1 tank (refer to Figure 1).

Leakage situation around the H6 tank area

- Water leaked outside the dike (100 m³)
- (1) Near the H6 tank area
- (2) U-shaped gutter with electric cables
- (3) Desalination (boiler) system area
- (4) Side ditch (not connected to the drainage ditch)

Leakage situation in area (1)

Leakage situation in area (3)

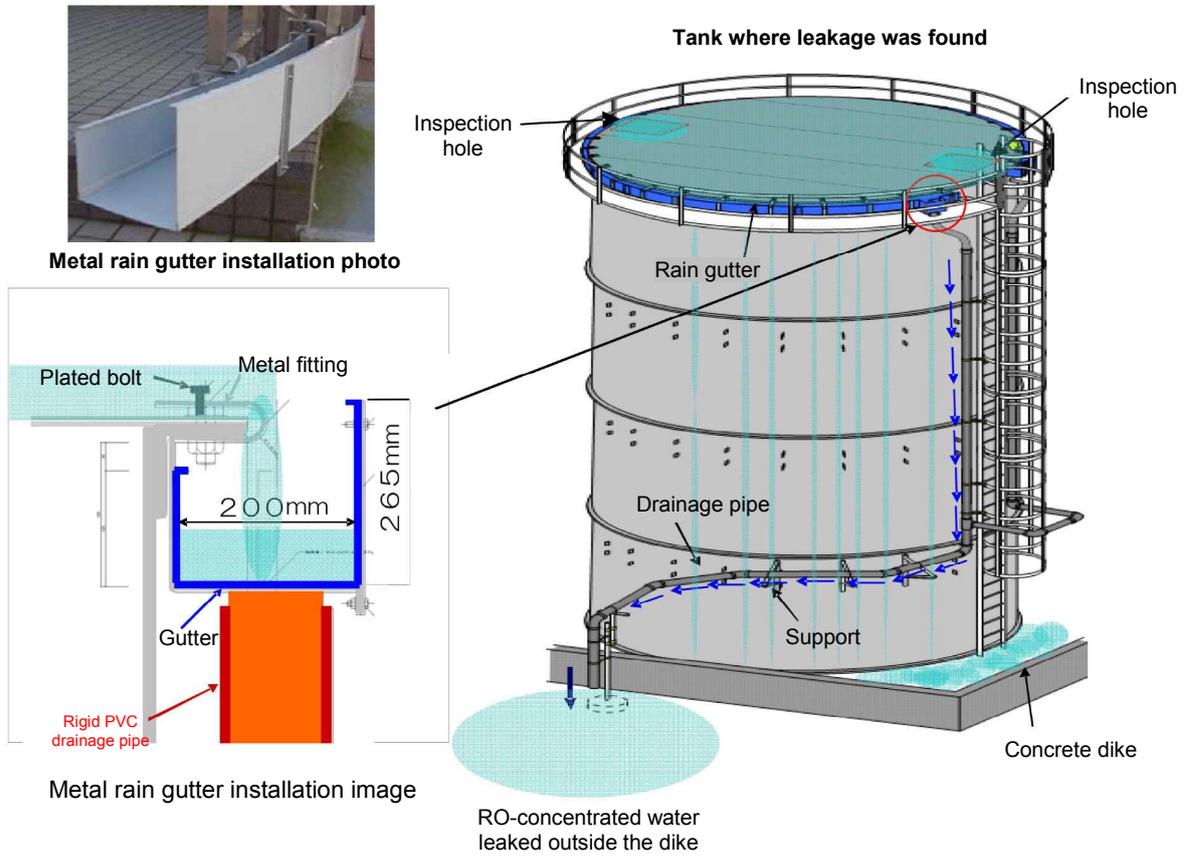
Figure 2 Leaked water flow-out route (extracted from the TEPCO report)

The water that had leaked from the ceiling plate of the C1 tank dripped into the dike,³ whereupon it flowed outside the dike through the rain gutter for draining rainwater that had accumulated on the ceiling plate (refer to Figure 2).

- RO-concentrated water leaked out of the dike through the rain gutter.
- The rain gutter was installed to discharge rainwater from the dike as a dike rainwater control countermeasure.

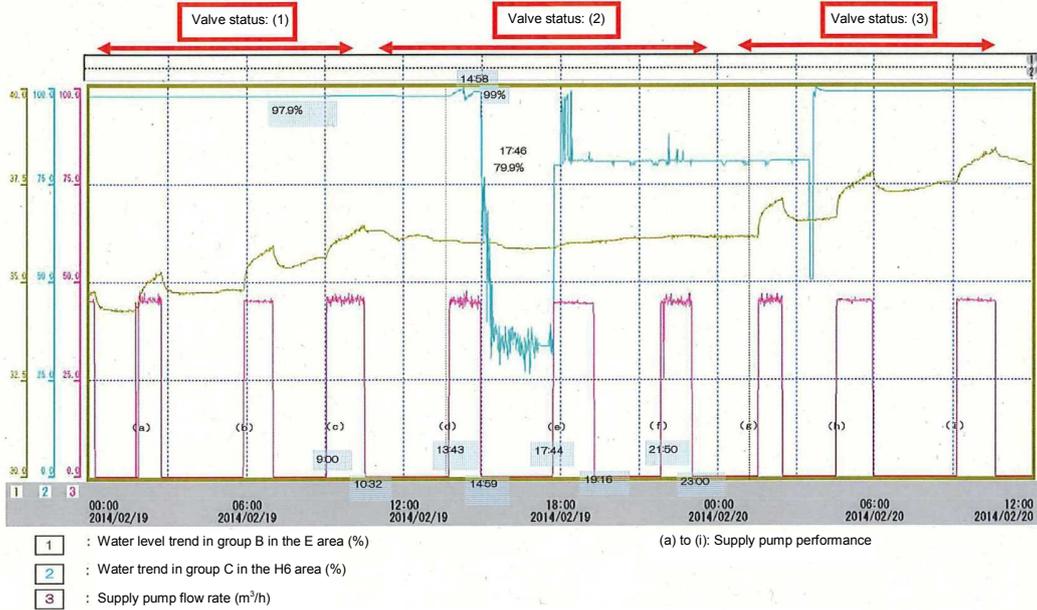
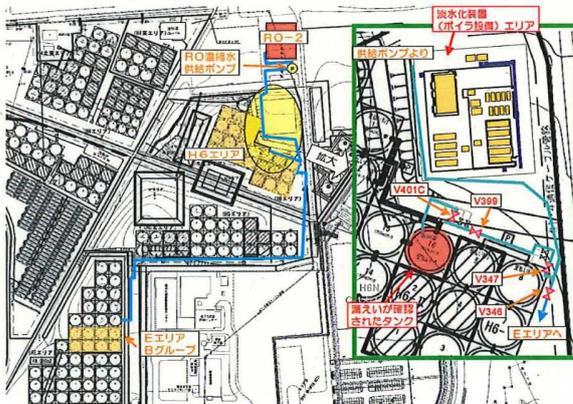
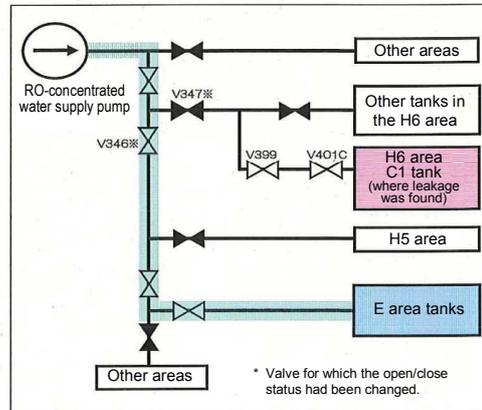
Figure 3 Tank water level, etc. (extracted from the TEPCO report)

The contaminated water was supposed to be transferred to the tank in the E area. However, at the time the leakage occurred, the line was configured to transfer contaminated water not to the E area but rather to the C1 tank in the H6 area. Incidentally, at the time the leakage was found, the line had been restored to its original configuration, in which contaminated water is transferred to the E area (refer to Figures 3 and 4).

- (i) Leakage of contaminated water was not prevented because the following two signs of equipment abnormalities were overlooked.
 - Even though contaminated water was being transferred to the tank in the E area, the water level of the relevant tank was not increasing.
 - Even though a high-high alarm for the water level of the tank in the H6 area was issued, it was not investigated sufficiently.
- (ii) Opening/closing management of valves was not carried out.
 - The environment made it easy for valves to be opened and closed.
 - Instructions regarding opening/closing operation and management for valves were insufficient.

Results of the survey on tank water levels and valve open/close status management

Supply pump operation status and tank water level trend

System schematic diagram (condition upon starting transfer on 17 Feb.)

- (i) In monitoring by an operator during RO-concentrated water transfer, on an hourly basis the operator confirms that the supply pump's activation state and the transfer destination tank's water level are in sync with each other. In addition, if an abnormality is found with respect to the trend in water level, the operator is to

stop the supply pump and check the line configuration and whether water leakage has occurred on-site.

- (ii) Besides the operator, the person on duty in the seismic isolation tower also monitors the tank water level, thus serving as a double-check function.
- (iii) Two water level monitoring screens for the transfer destination and branch area are placed adjacent to one another so as to visually facilitate simultaneous monitoring of the water levels of both the transfer destination and branch area.

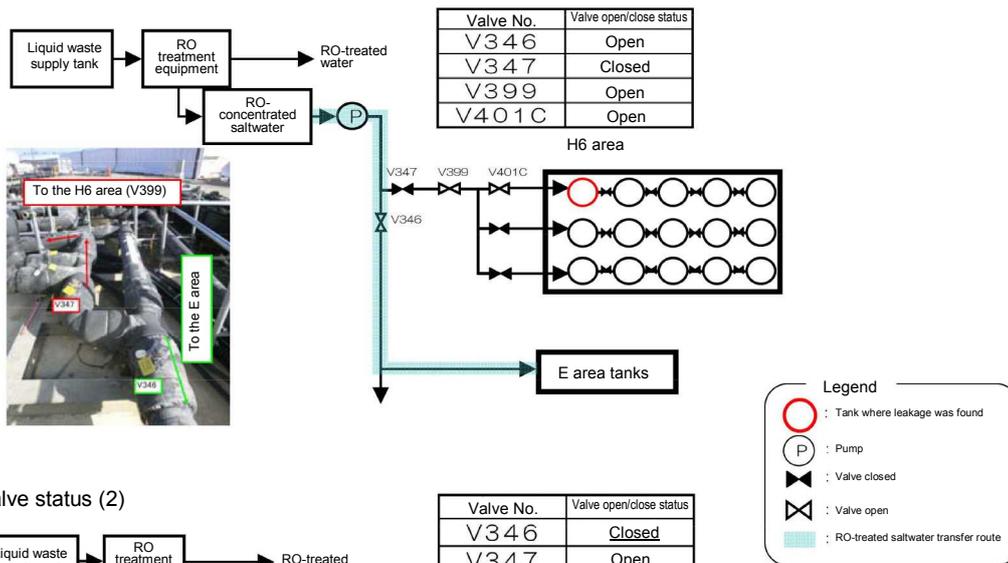
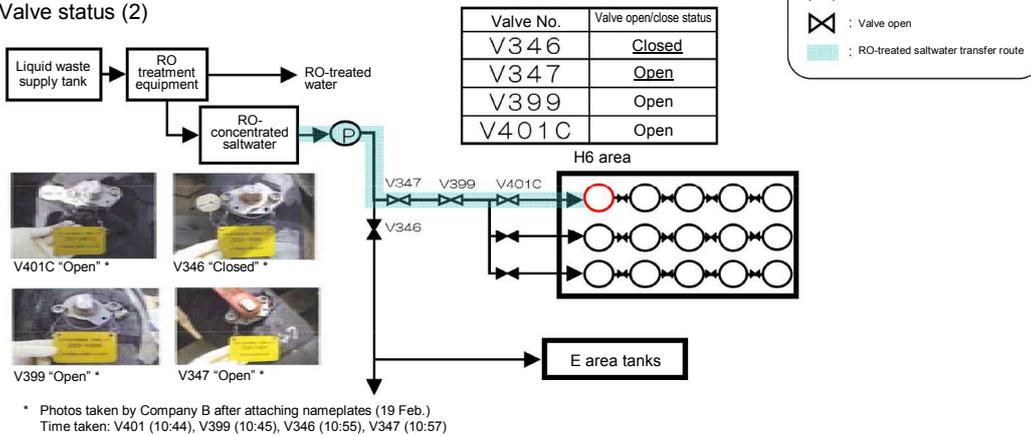
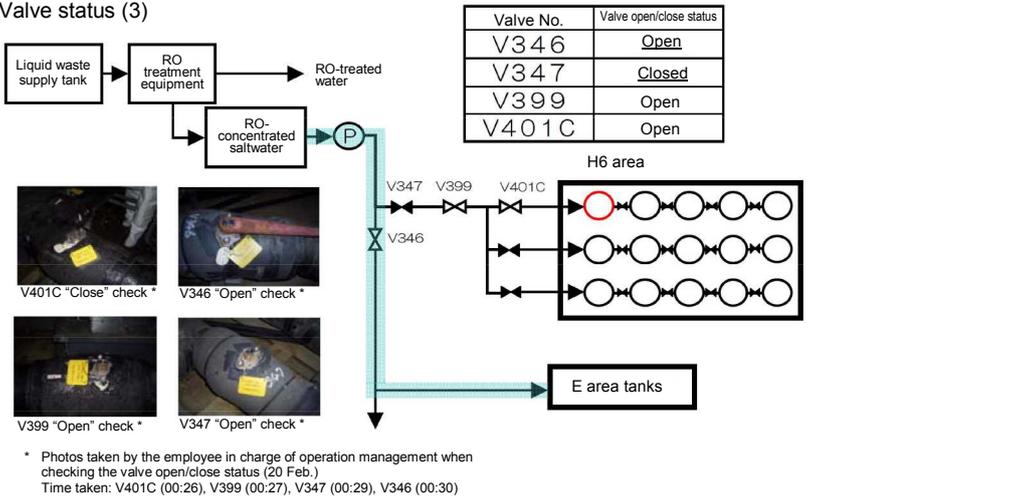
Figure 4 Valve open/close status (extracted from the TEPCO report)

Valve status (1)

Valve status (2)

Valve status (3)

- (i) Enhancement of locking management
 - Valves will be locked and their keys will be managed only by personnel involved in operation.
 - The open/close status of valves on the transfer line will be checked daily.
 - The open/close status of valves will be recorded.
- (ii) Enhancement of patrols
 - The frequency of patrols by the person on night duty will be increased from once to twice per night.
 - Patrols by the maintenance management department will be performed twice per day.
- (iii) Enhancement of monitoring cameras
 - Additional monitoring cameras will be installed, and video recording functionality will also be added.
 - Lighting will be enhanced.

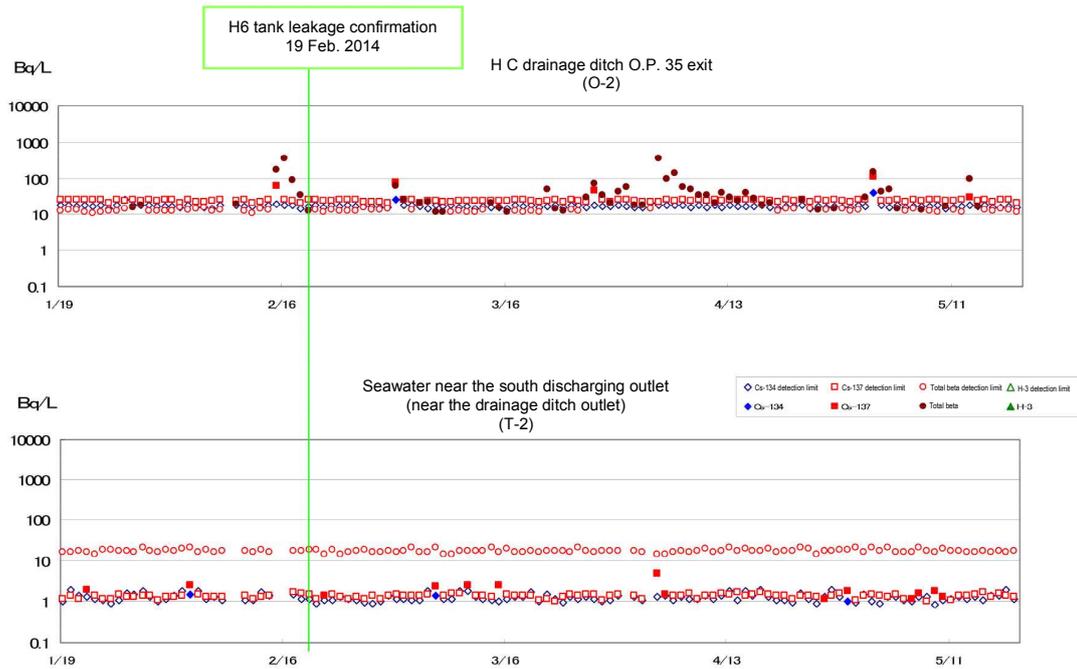
Figure 5 Results of monitoring the drainage ditch and seawater monitoring (extracted from the Secretariat of the NRA's document for a meeting with TEPCO)

There is no obvious fluctuation in the results of monitoring before and after the leakage occurred in the vicinity of the south discharging outlet (T-2) of the C south drainage ditch. The NRA therefore concludes that this event did not cause ocean contamination that raises any concerns about effects on health or the environment (refer to Figure 5).
