News Release

6 February, 2014 Nuclear Regulation Authority, Japan

On 6 February 2014, the Nuclear Regulation Authority (NRA) of Japan received a report from TEPCO regarding the leakage of water, which was treated by Simplified Active Water Retrieve and Recovery System (SARRY, cesium removal facility) and Reverse Osmosis Desalination Facility (RO) at Fukushima Daiichi Nuclear Power Station, pursuant to the Act on Regulation of Nuclear Source Material, Nuclear Fuel Material and Nuclear Reactors. The report delineates as follows:

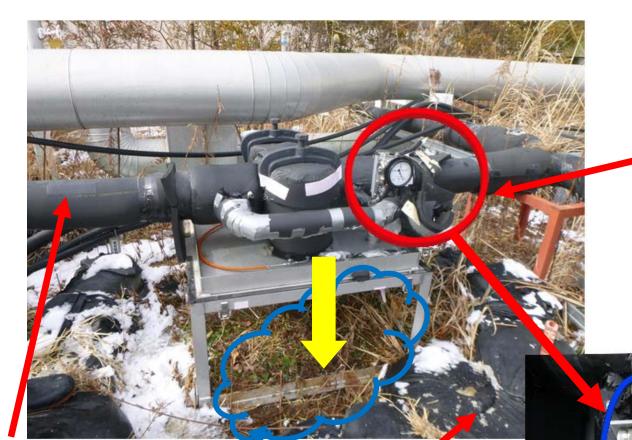
Attachment 2

- It was found by TEPCO on 6 February that the water treated by SARRY and RO was leaking from the flange of water pressure measuring instrument equipped to the water pipe in which the water was running to the Nuclear Reactors Unit 1 to 3 for their cooling. The leaked water was flowing into the underground nearly under the water pressure measuring instrument.
- The water leakage from the flange was stopped by TEPCO by means of closing the valve attached between the flange and the water pipe.
- The amount of leaked water is estimated by TEPCO to be approximately 600 litters in total.
- The concentration of radioactive materials in the water treated by SARRY and RO is as follows (Sampling date: 10 December 2013):

Flange from which the water leaked.

Ground surface to which the leaked water flowed.

TEPCO is working now on measuring the concentration of radioactive materials in the water running in the above-described water pipe. And it plans to remove the ground soil, to which the leaked water flowed, to the tentative storage place on site.
