## **Discovery of a crack in a connection valve between tanks for concentrated water\* treated by Reverse Osmosis at Fukushima Daiichi NPS**

On 17 September 2014, the Nuclear Regulation Authority (NRA) of Japan received a report from TEPCO regarding a recent incident at Fukushima Daiichi NPS, pursuant to the Act on Regulation of Nuclear Source Material, Nuclear Fuel Material and Nuclear Reactors. The report delineates as follows:

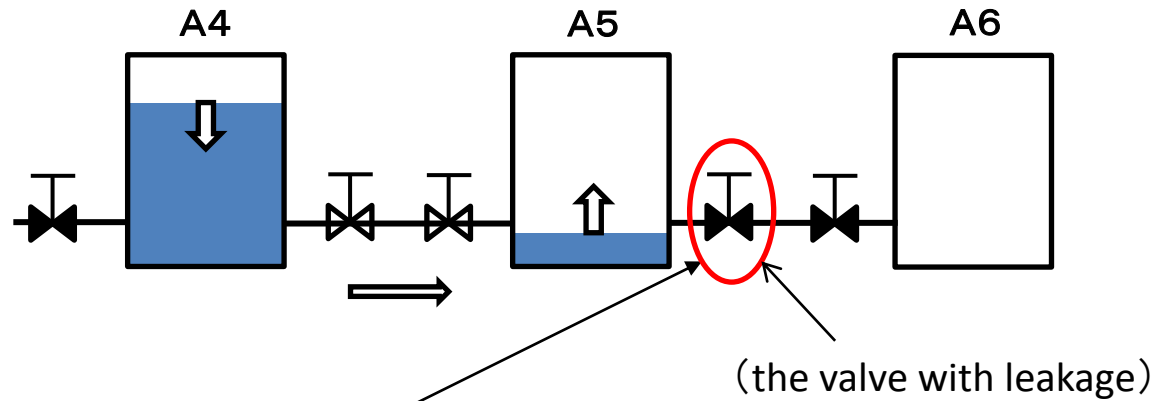
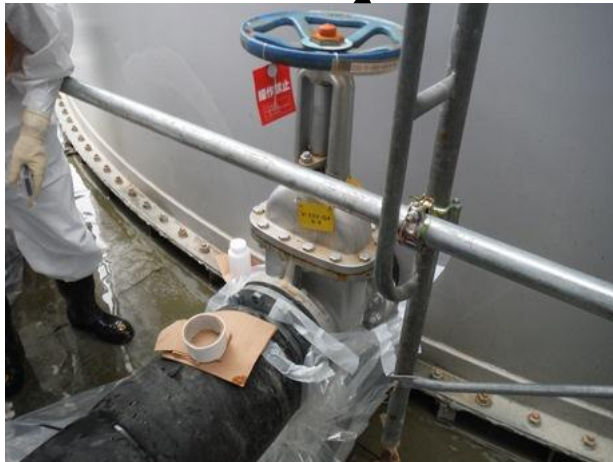
## Location of the valve with the crack and leakage

- TEPCO found on 4 September that the concentrated water treated by Reverse Osmosis (RO) was leaking from a connection valve between A5 tank and A6 tank in the G4 South Tank Area. The leaked water was remaining within the dike surrounding the area.
- As a result of inspection by TEPCO, it was found on 17 September that the connection valve had a crack which penetrated the valve.
- Therefore, this crack constitutes a lack of functionality in ensuring safety in the nuclear reactor facility under TEPCO's Implementation Plan.

the valve where the leakage was found

- To swiftly inspect similar valves connecting storage tanks which are not surrounded by dikes, to ensure there are no cracks.
- To take prevention measures including review of inspections of equipment (i.e. tanks, valves and connection pipes) in light of the result of cause-finding measure.

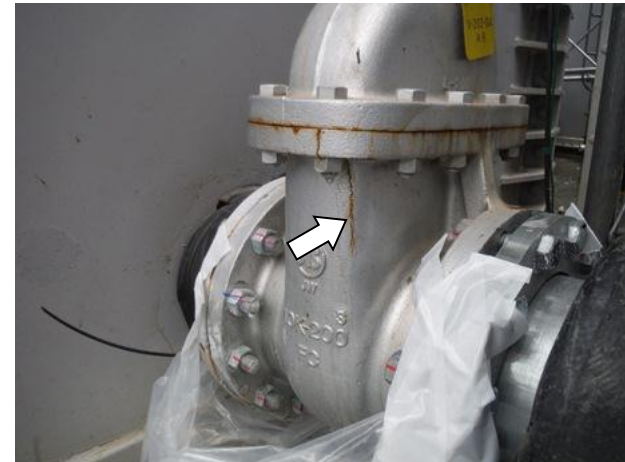
location of the crack
