Evaluation of the report of Tokyo Electric Power Company regarding the leakage from the RO-3 contaminated water treatment facility desalination system (reverse osmosis membrane system) at Fukushima Daiichi Nuclear Power Station

15 April 2015

Nuclear Regulation Authority, Japan

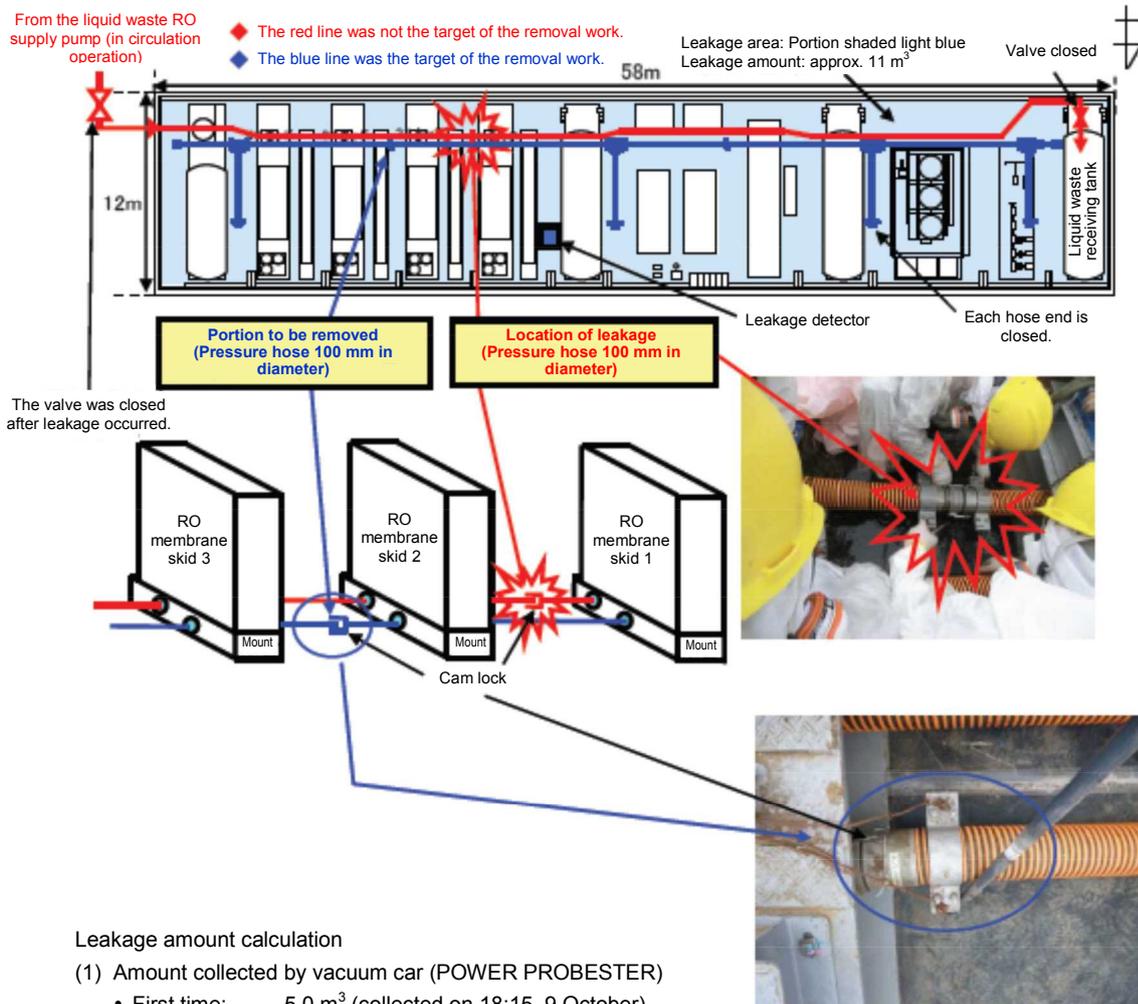
Figure 4 Leakage situation in the RO-3 cornice house and leakage amount (extracted from the TEPCO report)

The worker who was replacing the pressure hose with PE piping as part of reliability improvement measures misidentified an adjoining pressure hose as being the one subject to replacement and mistakenly removed a cam lock with no identification marking (refer to Figures 4 and 5).

Although the amount of leaked water was approximately 11 m³, it remained inside the cornice house dike and did not spread outside the dike. In terms of total beta, the radioactive concentration was 3.4×10^7 Bq/L, while the total amount of radioactivity was approximately 3.7×10^{11} Bq.

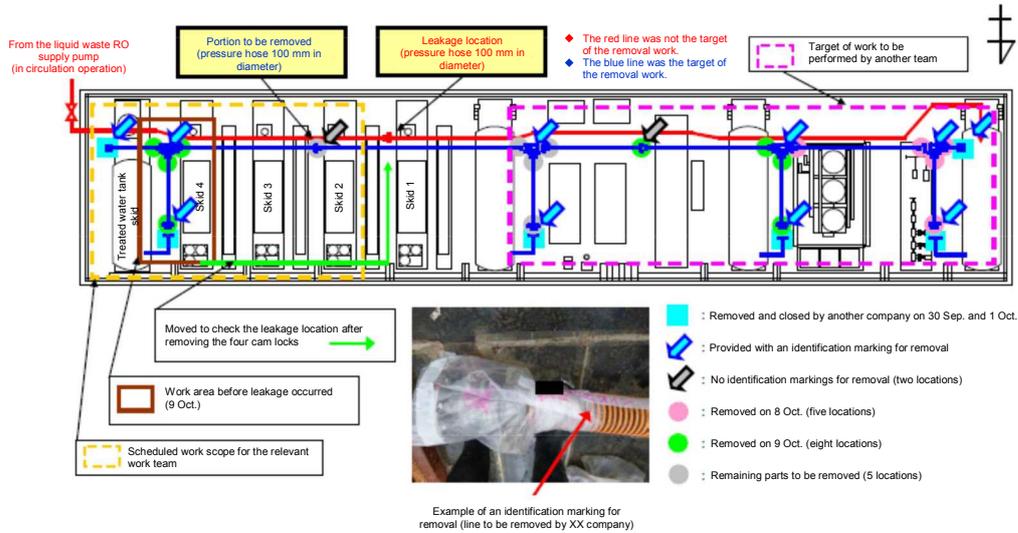
Figure 5 Situation regarding cam lock removal while removing the pressure hose to replace it with PE piping (extracted from the TEPCO report)

The adjoining pressure hose from which the cam lock was mistakenly removed was in operation and had water passing through it; therefore, leakage occurred. The leakage was stopped by shutting down the waste liquid supply pump and reconnecting the cam lock.

The leakage was caused by performing the work without sufficient safety measures such as isolation as well as failing to provide clear identification markings.

- a. As a procurement requirement, the additional work specifications stipulate that identification markings must be provided and checked by the work supervisor when removing or attaching important cables, piping or the like during remodeling or similar work.
- b. The safety assessment guidelines have been reviewed so that risks present during work can be reduced by accurately extracting them during safety assessments.

Based on the fact that the misidentification of the cam lock was due to the failure to require identification markings at the time of procurement, a requirement that identification markings be added and checked by the work supervisor has been stipulated in the additional specifications for work.

Based on the fact that the leakage occurred because the adjoining pressure hose from which the cam lock was mistakenly removed was in operation and water was passing through it, a review of the safety assessment guidelines has been conducted so that safety measures (such as conducting risk assessment and removing risks before starting work) are taken.

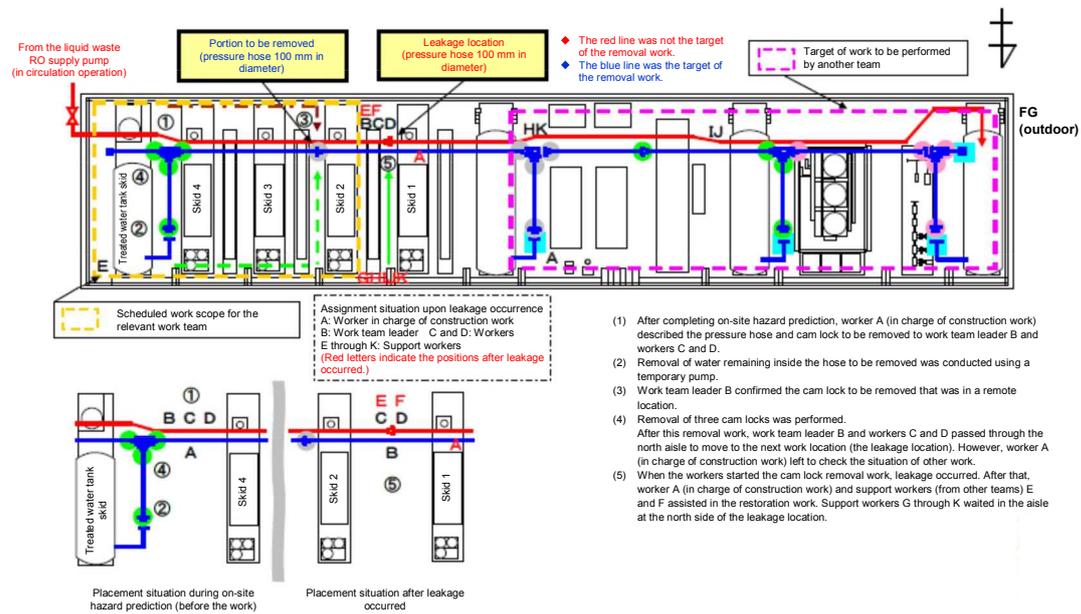
Figure 6 Work and assignment situation at the site before and after leakage occurred (extracted from the TEPCO report)

When contamination occurred from the cam lock, the workers did not immediately leave the site but instead performed water cut-off work without sufficient equipment. For this reason, six of the eleven workers were found to have bodily contamination below the neck (refer to Figure 6 and Table 1). For five of these six workers who were wearing anoraks, contamination may also have occurred when taking off the anoraks because they did not first remove the contaminated water and other substances on the anorak surface.

Bodily contamination occurred because the workers did not implement sufficient radiation protection measures; for example, they performed water cut-off work without sufficient equipment and did not remove contaminated water and other substances on their anoraks when removing the anoraks.

- a. Leave the leakage site if there is a risk of bodily contamination, even if it has become necessary to perform unscheduled work.
- b. When performing restoration work, including water cut-off work, follow the stipulated rules and wear appropriate protective equipment.
- c. Before taking off anoraks⁵ on which contaminated water is present, carry out appropriate measures, such as removing the contaminated water.
