Evaluation of the report of Tokyo Electric Power Company regarding the leakage from the RO concentrated water storage tank at the Fukushima Daiichi Nuclear Power Station

31 March 2015
Nuclear Regulation Authority, Japan

10 December 2014
Nuclear Regulation Authority, Japan

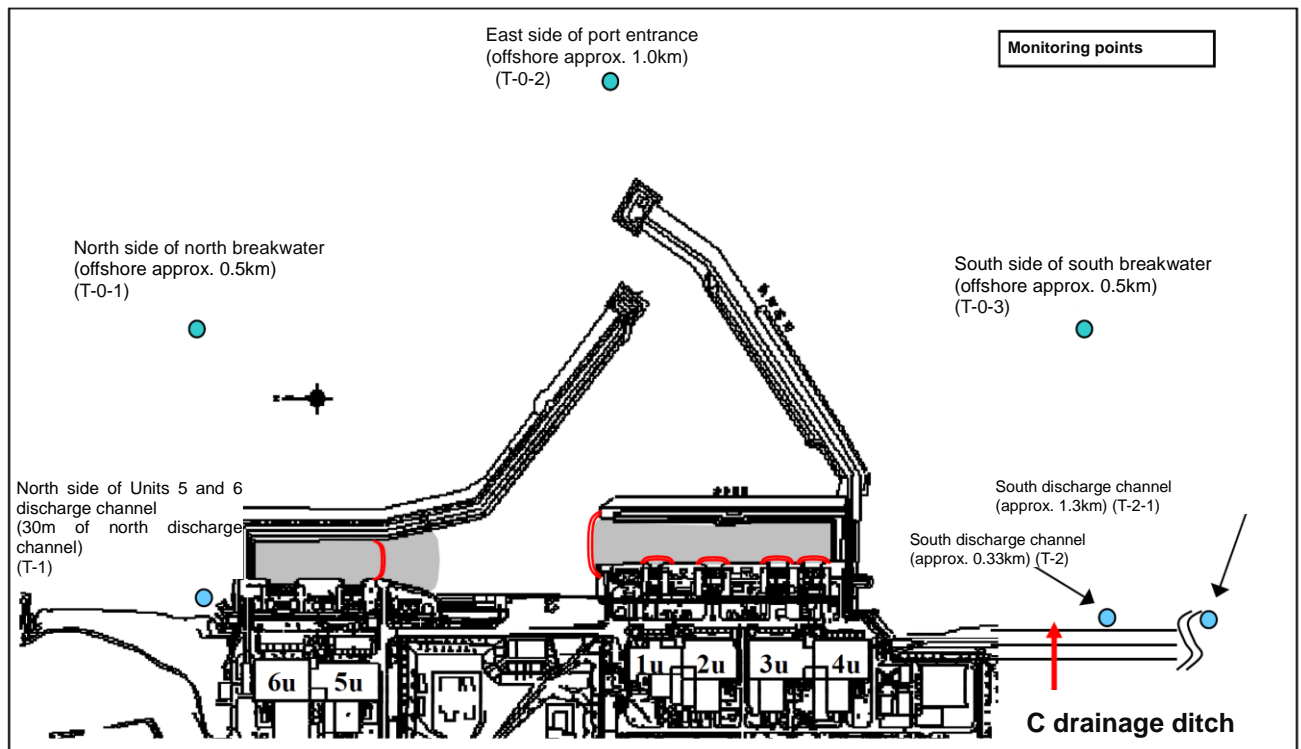
Figure 2 Sampling points of seawater^{*2}
(As of October 2013)

In terms of an environmental impact, no obvious increase in measurement results of total beta was detected in the seawater monitoring (refer to Figure 2) at the north/south discharging outlets (refer to Figure 3).
