Evaluation of the report of Tokyo Electric Power Company regarding the leakage from the 4000-t square steel tank cluster at the Fukushima Daiichi Nuclear Power Station

28 April 2015

Nuclear Regulation Authority, Japan

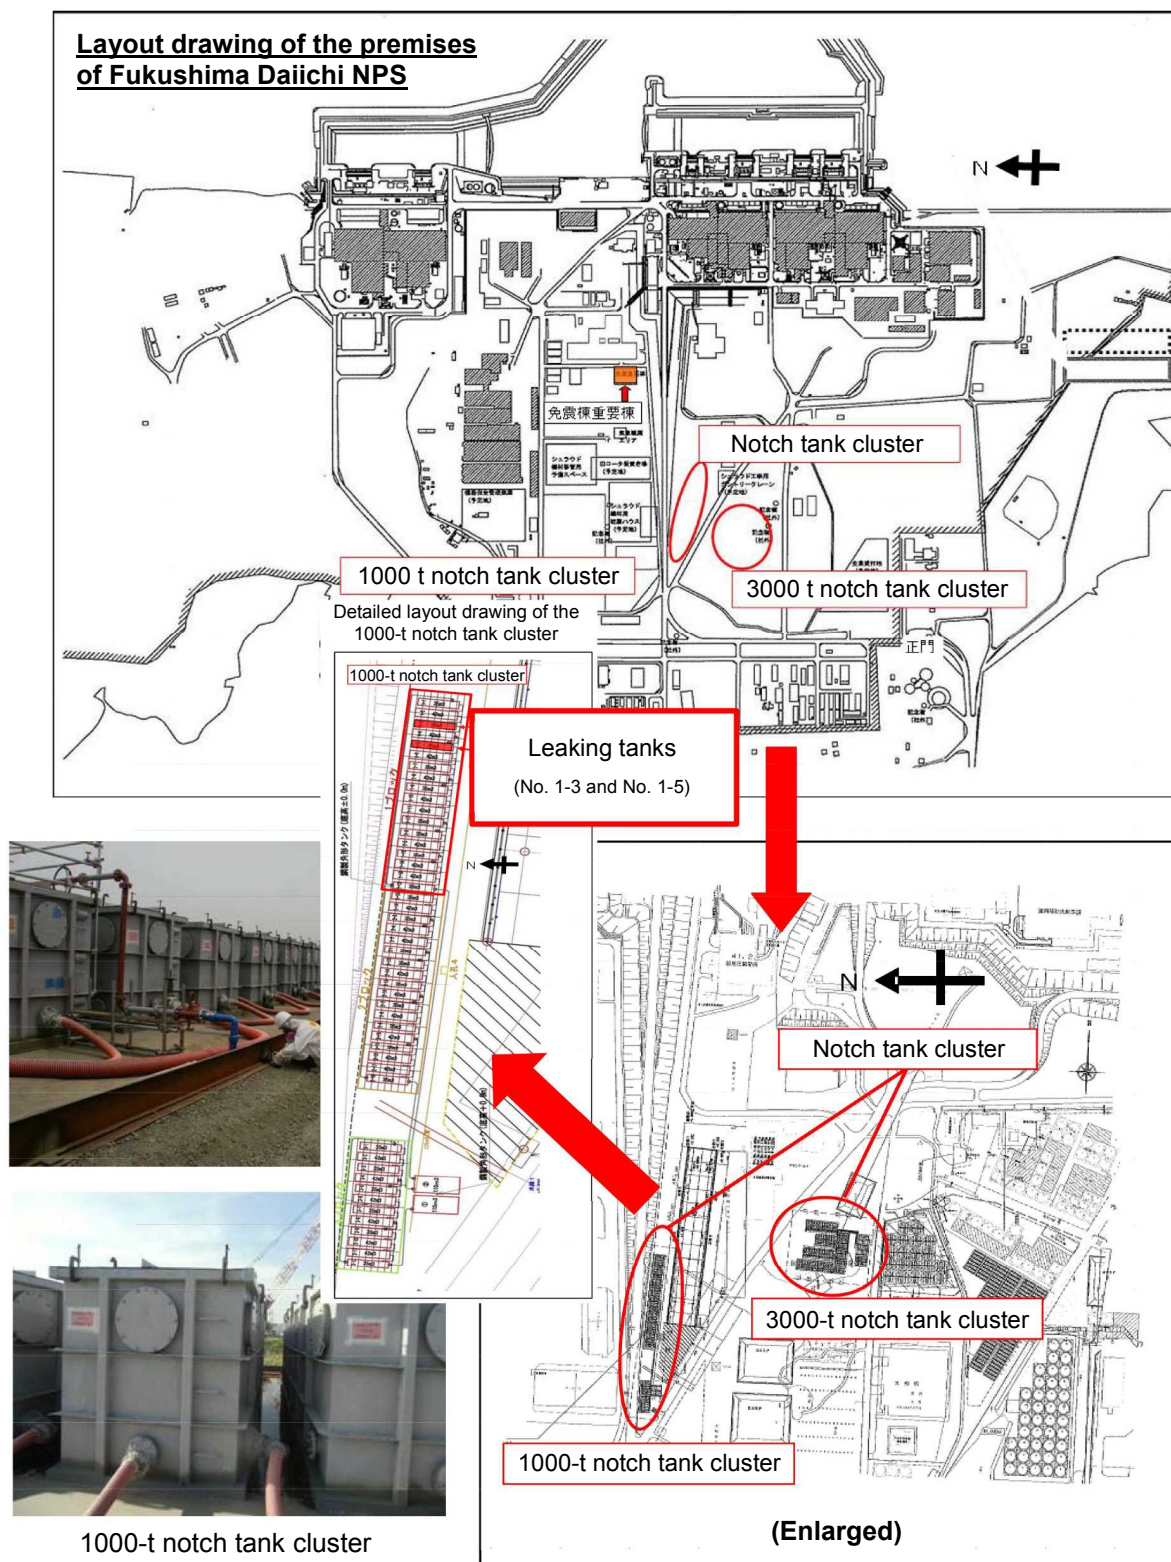
Figure 1 Layout of the notch tank cluster (extracted from the TEPCO report)

Around 14:00 on 2 June 2014, a nuclear safety inspector patrolling the site found water leaking from portions around bolts (refer to Figures 2 and 3) attached to the upper parts of the sides of two tanks (Nos. 1-3 and 1-5, 35 m³ tanks) of the 1000 t square steel tank (hereinafter, referred to as “notch tank”) cluster, which is part of the 4000 t notch tank cluster* (refer to Figure 1).
