Evaluation of the report of Tokyo Electric Power Company regarding the leakage from the RO-3 contaminated water treatment facility desalination system (reverse osmosis membrane system) at Fukushima Daiichi Nuclear Power Station

15 April 2015

Nuclear Regulation Authority, Japan

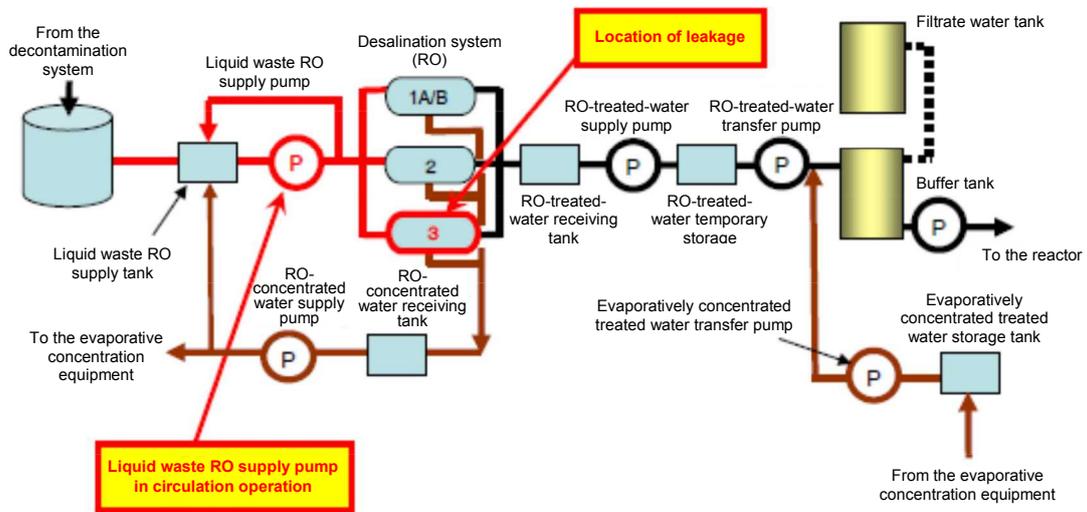
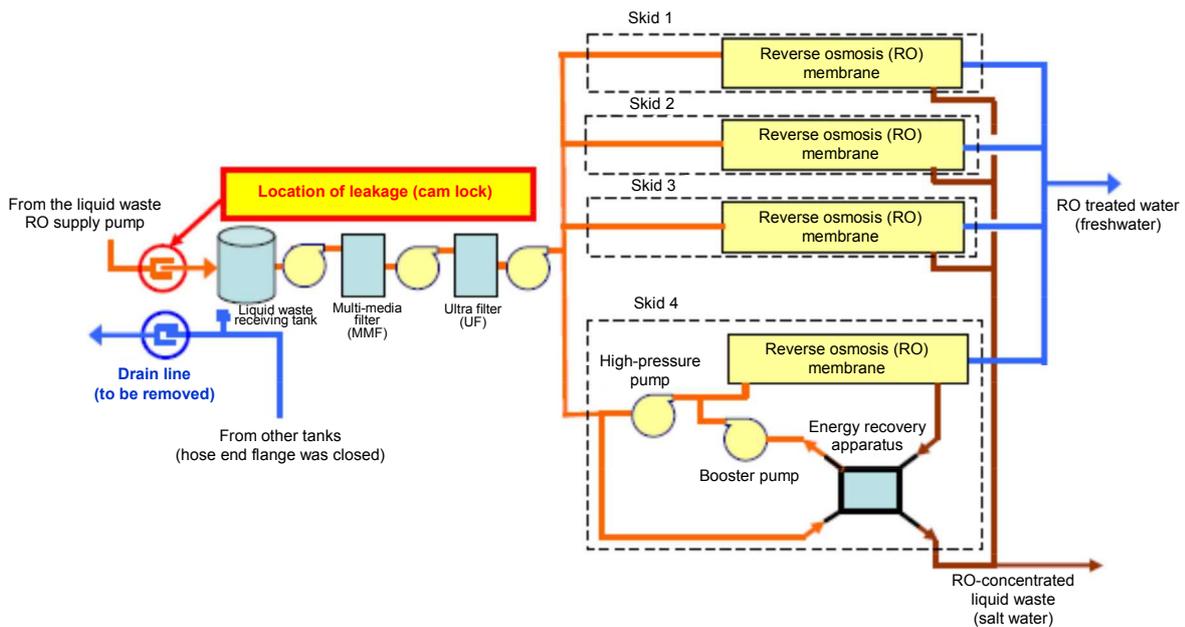
Figure 3 Overview of the desalination system (extracted from the TEPCO report)

Schematic diagram of the desalination system

Structure of the RO-3 cornice house
