Leakage of Water Treated by the Multi-Nuclide Removal Facility (ALPS) at Fukushima Daiichi NPS – Confirm No Leakage to Ocean

The report delineates the event in which water treated by the Multi-Nuclide Removal Facility (ALPS)* leaked from an open end of a branch pipe branching off the main pipe.

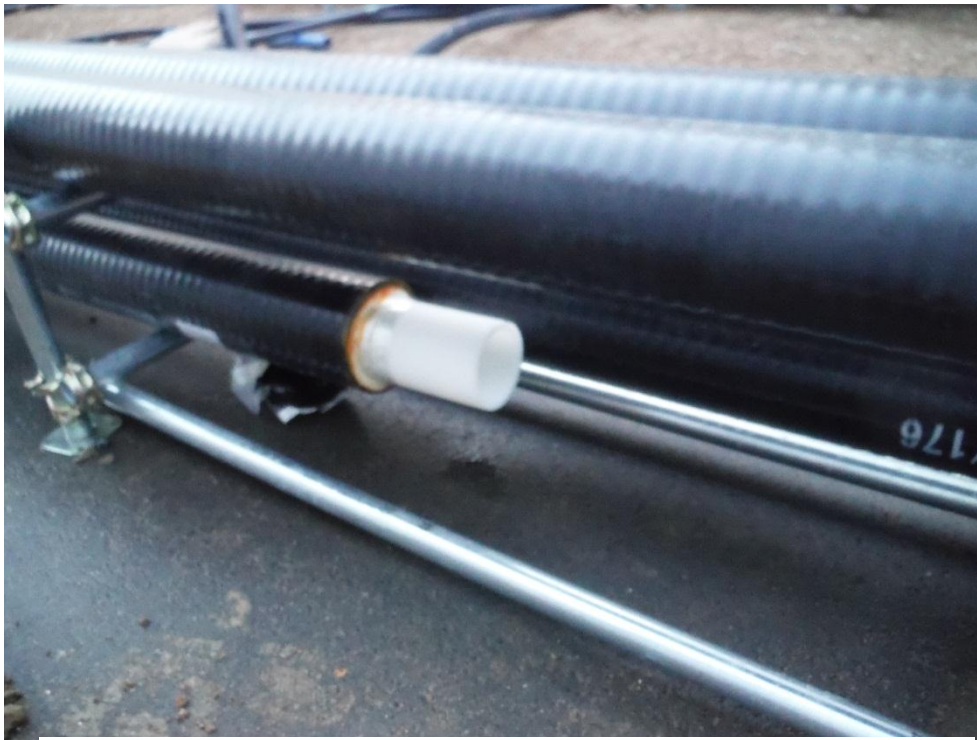
- At around 3:00 pm on 17 December 2014, treated water being transferred to the J6 Tank Area at Fukushima Daiichi NPS was found leaking from an open end of a branch pipe connected to the main pipe.

- While having an open end, the valve on the branch pipe was open. Closing the valve on the branch pipe stopped the leakage. The estimated volume of the leaked treated water is approximately 6 tons, based on the flow rate and time.

Open end of the branch pipe which caused the leakage

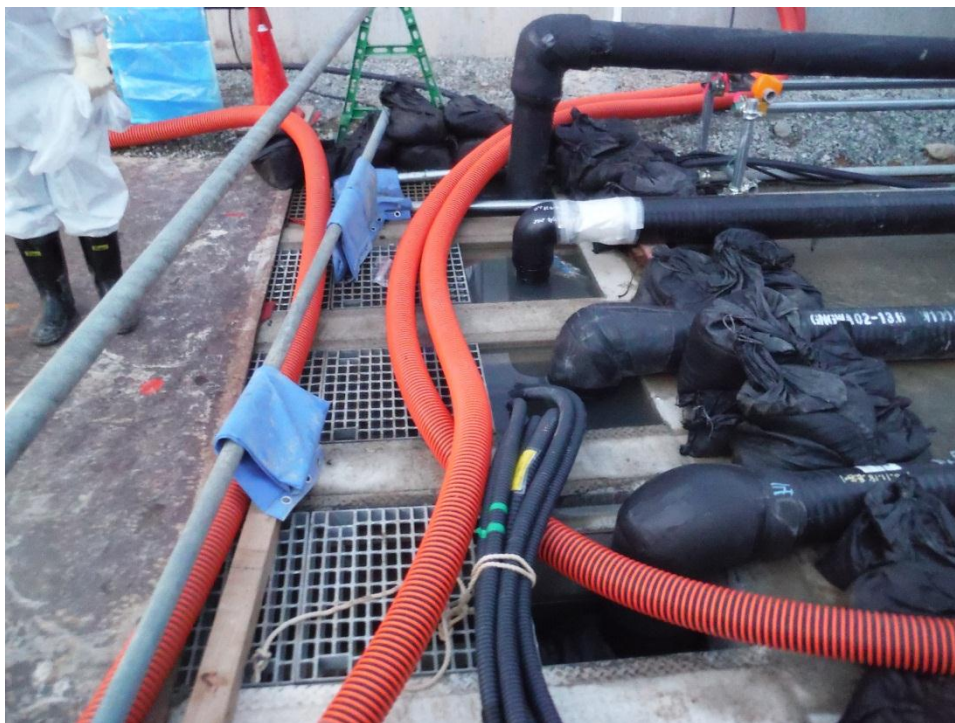
- The leaked treated water was also found accumulating in the closed pipe trench at a lower elevation from the point of leakage.

Accumulated water in the pipe trench

- Approximately 9 m³ of water – rainwater included – was removed from the pipe trench by 7:35 pm on 17 December. Approximately 20m x 0.5m of soil soaked with water was removed by 5:30 pm the same day.
